Eastern Bays and Glendowie Watercourse Assessment Report

Morphum Environmental Ltd, April 2020

Watercourse Assessment Report

Auckland Council
Healthy Waters Department
Watercourse Assessment Report

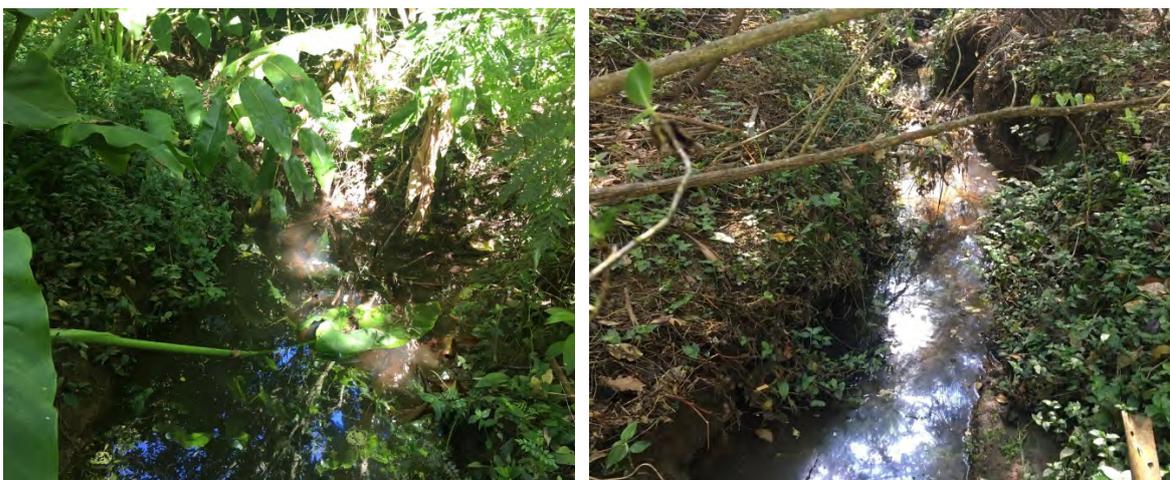
Erosion scarring on lower banks, noxious weed groundcover along KOH_MAIN_16.

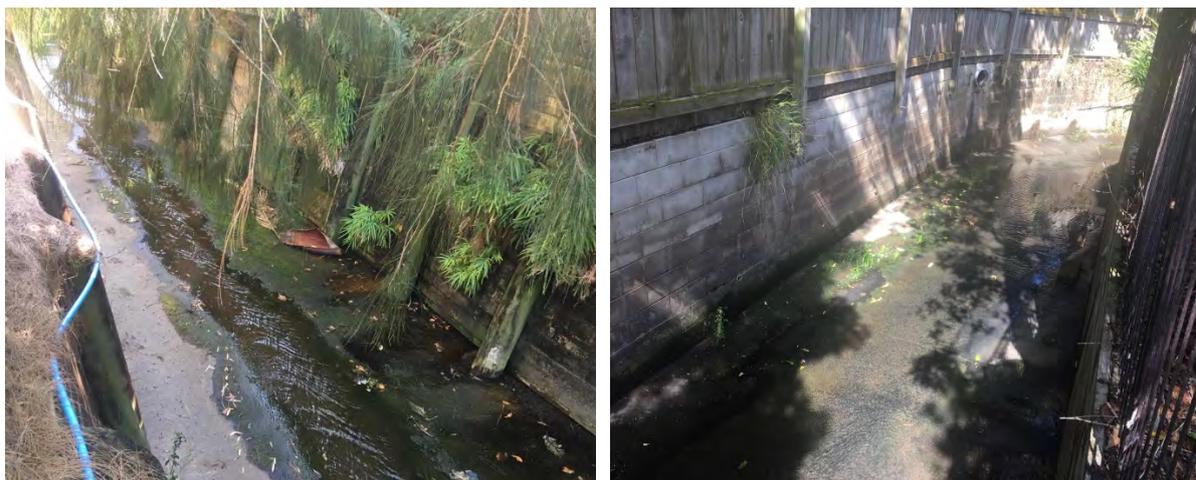
Figure 11: Typical examples of reaches in Management Zone 3. Concrete lined channels with timber bank lining on the upper reaches of the Glendowie Stream (GLE_TRIB4_9 left, GLE_TRIB4_5 right).

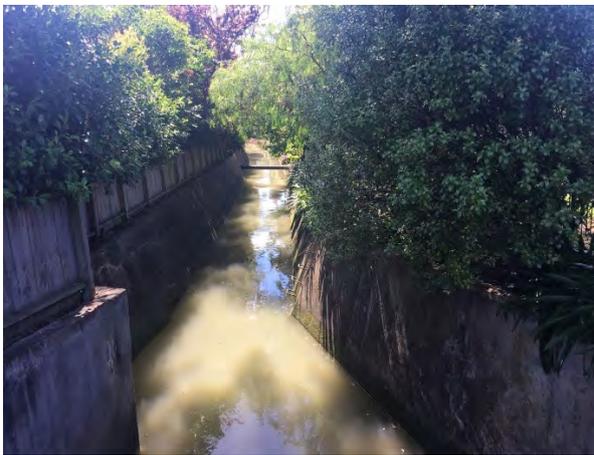
The coastal reaches located along KOH_MAIN 1 to KOH_MAIN_4, Mission Bay sub-catchment stream mouth are concrete lined with narrow riparian margins.

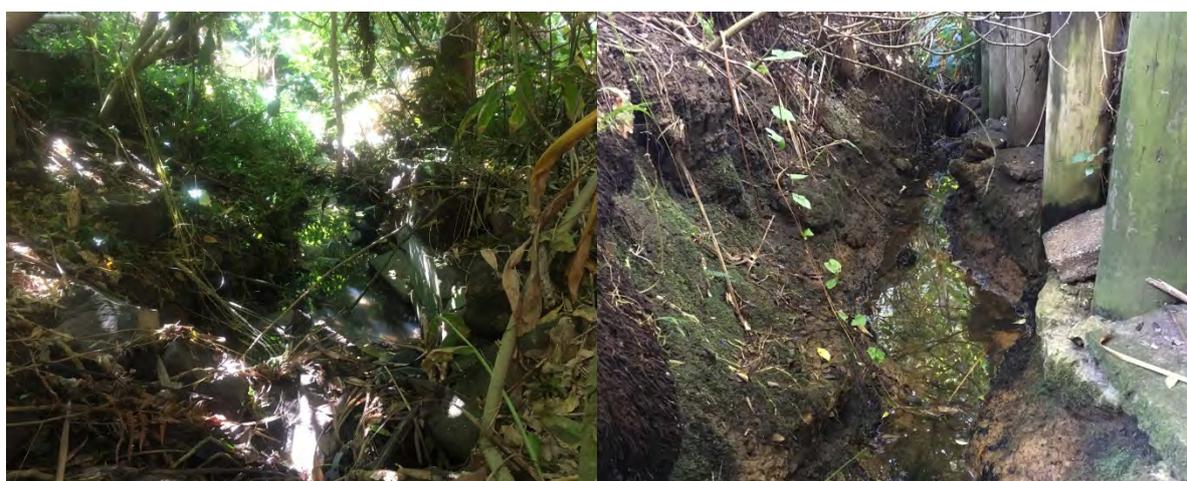
Modified reach along KOH_TRIB3a_6.

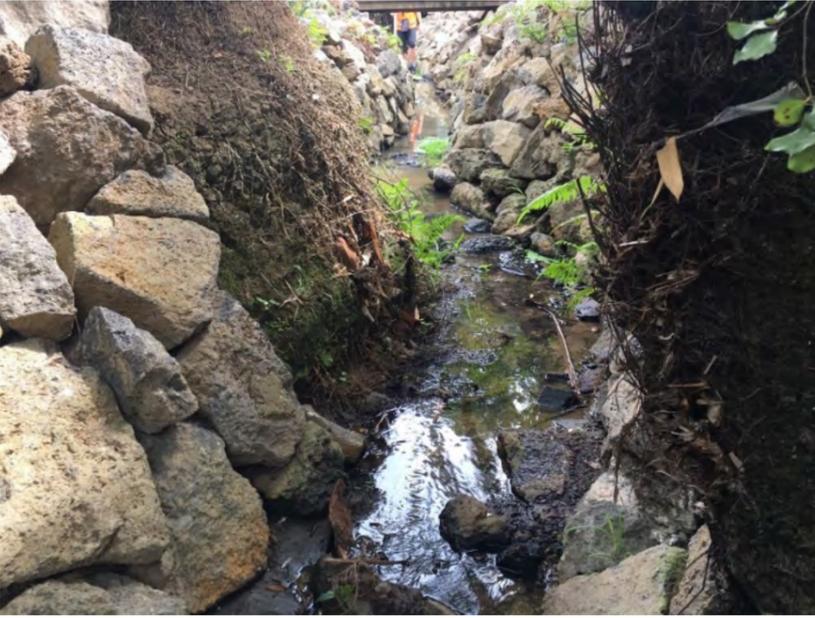
A reach of Mission Bay Stream through residential properties with riprap as bank lining (MIS_TRIB4_3).

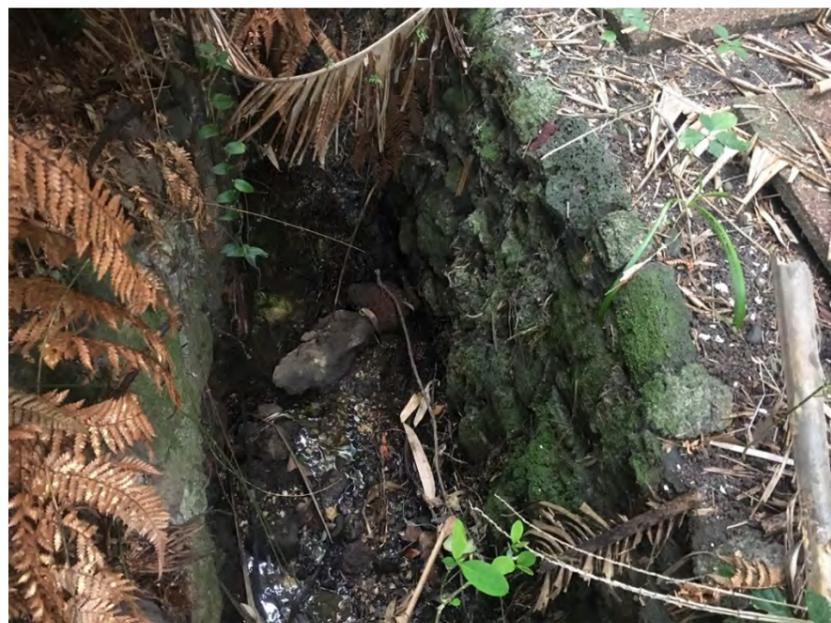
Approximately 70 m of Karaka Bay Stream is lined with concrete and rip rap (KAR_MAIN_1).

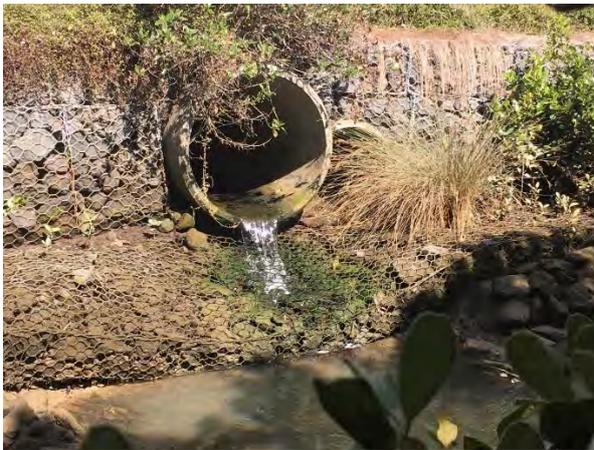
An Auckland Council owned asset (2000473115) is a complete barrier to fish passage. This pipe discharges into the Glendowie Stream Mouth and coastal marine area has a 1m drop height across reno mattress into the channel bed.

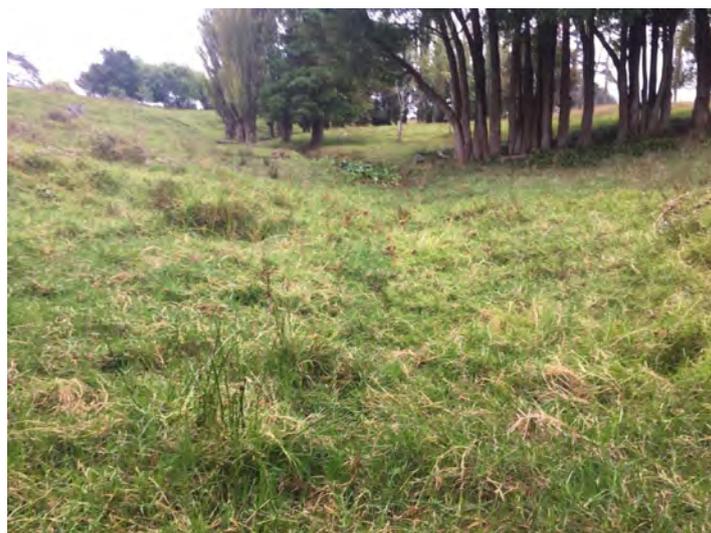
Figure 26: Natural riverine wetland in Churchill Park (Tributary ID: GEE_MAIN_FORK2a_1) caused by stock damage and pugging.

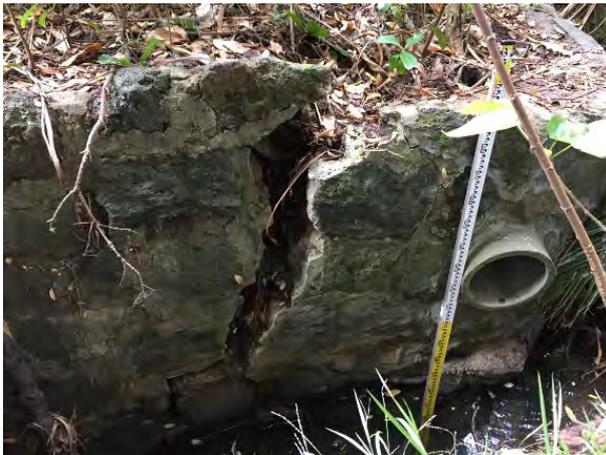
Detached headwall in Dingle Dell Reserve (2000649833).

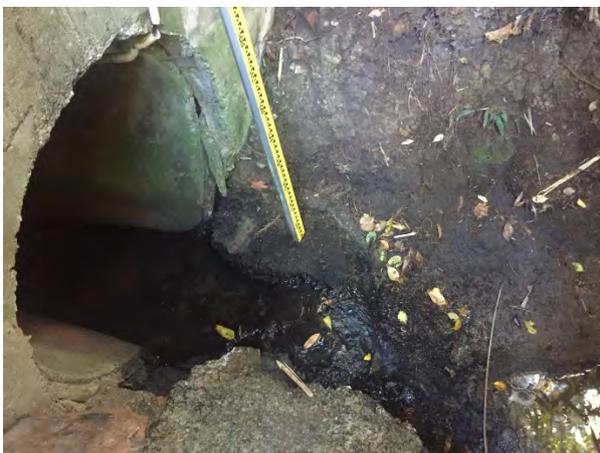
Informal cast in-situ concrete headwall that is cracked and erosion of the bare earth banks on both banks at 53 Clarendon Rd (2000677856).

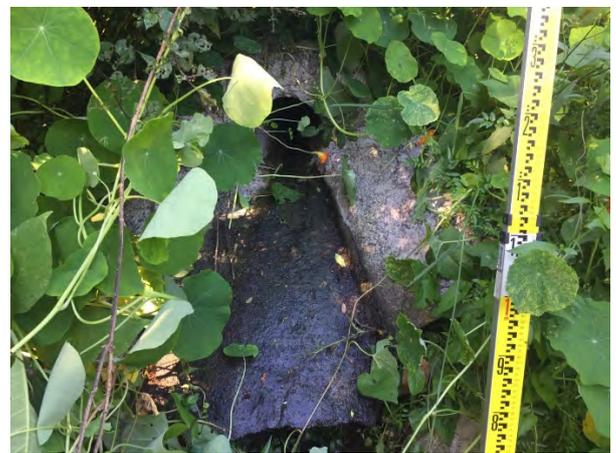
Informal concrete outlet at 23 Tarawera Terrace is undercut and may fall into stream channel (2000780248).

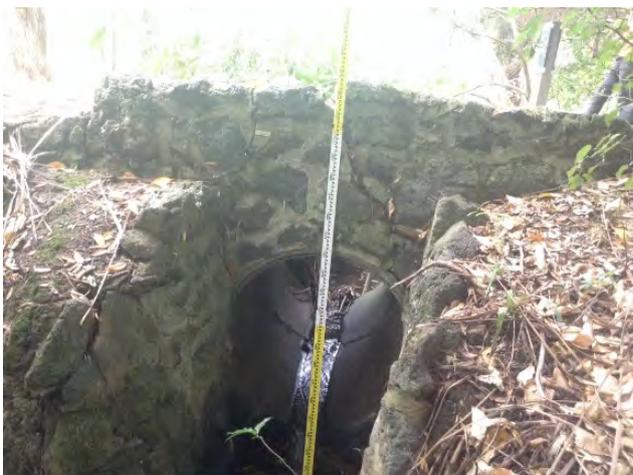
Cracked culvert bridge in Dingle Dell Reserve (EBS_004, EBS_005, EBSP_003).

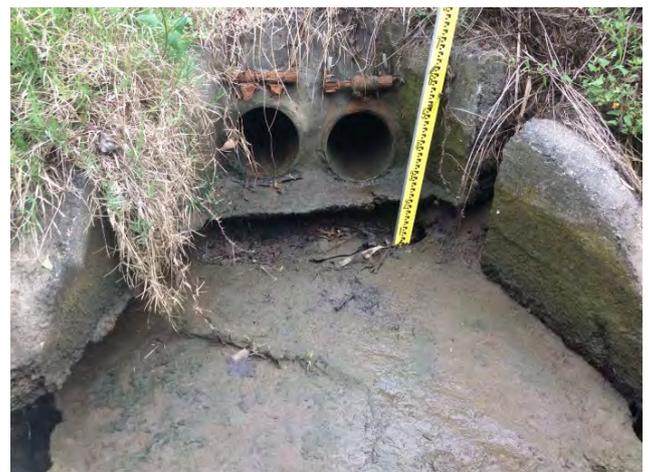
Outlet with detached wingwall, apron and snapped off tide gates (2000799090).

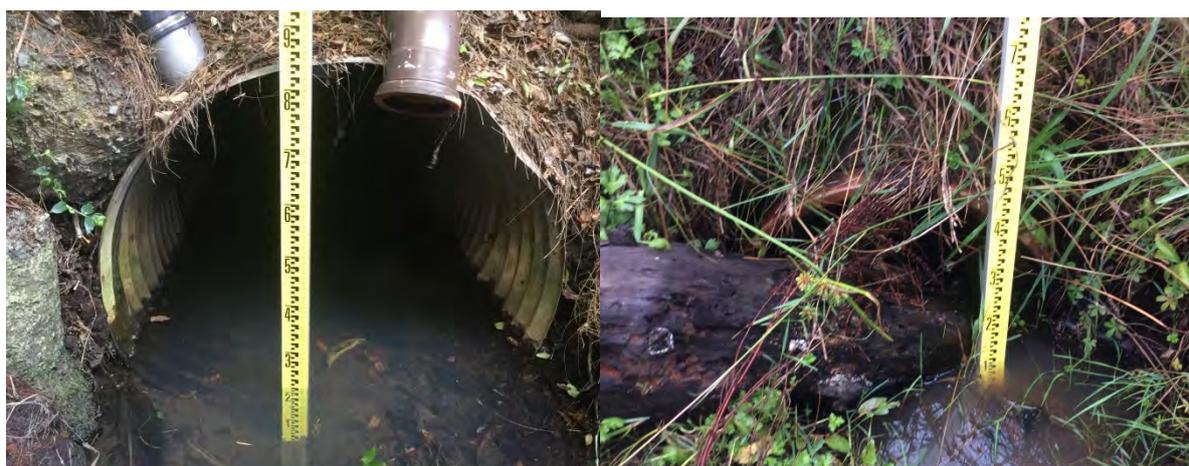
AC owned corrugated iron culvert on 23 Yattendon Road (2000176700) on private land needs lining with concrete or full replacement. Culvert in Churchill Park that is blocked and in poor condition (GLDSP_003).

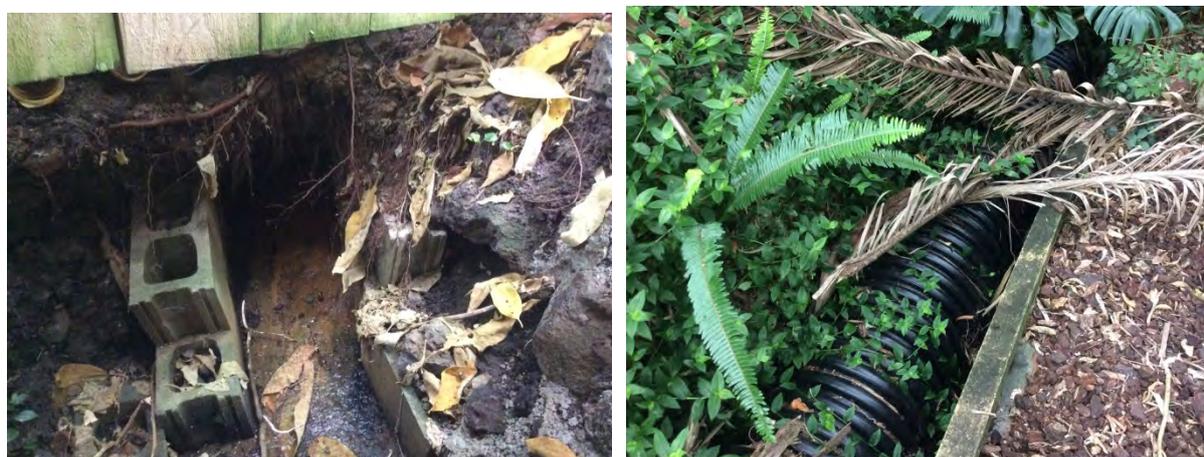
Cinder block culvert GLDSP_011.

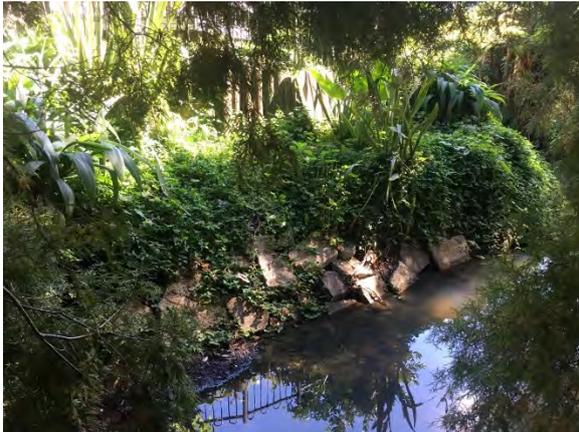
Bank lining in Churchill Park (AC land) (UNK_004) made up of poorly placed concrete blocks and gabion baskets.

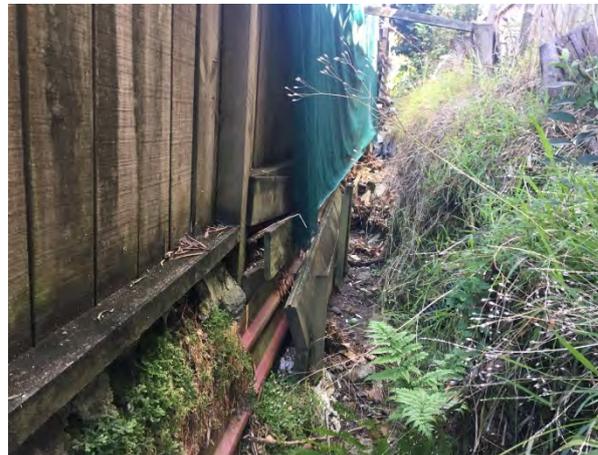
Haphazard bank lining encroaching on a nearby shed (STH_TRIB4_4) (UNK_056).

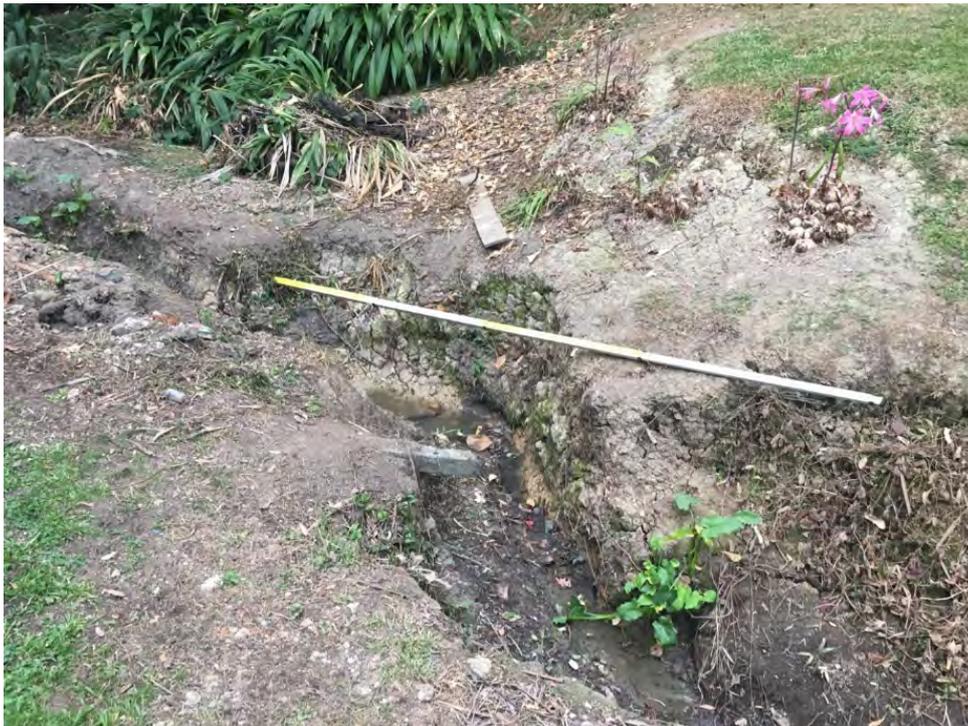
Figure 31: Erosion hotspot exacerbated on private property by poor riparian planting on MIS_MAIN_6.

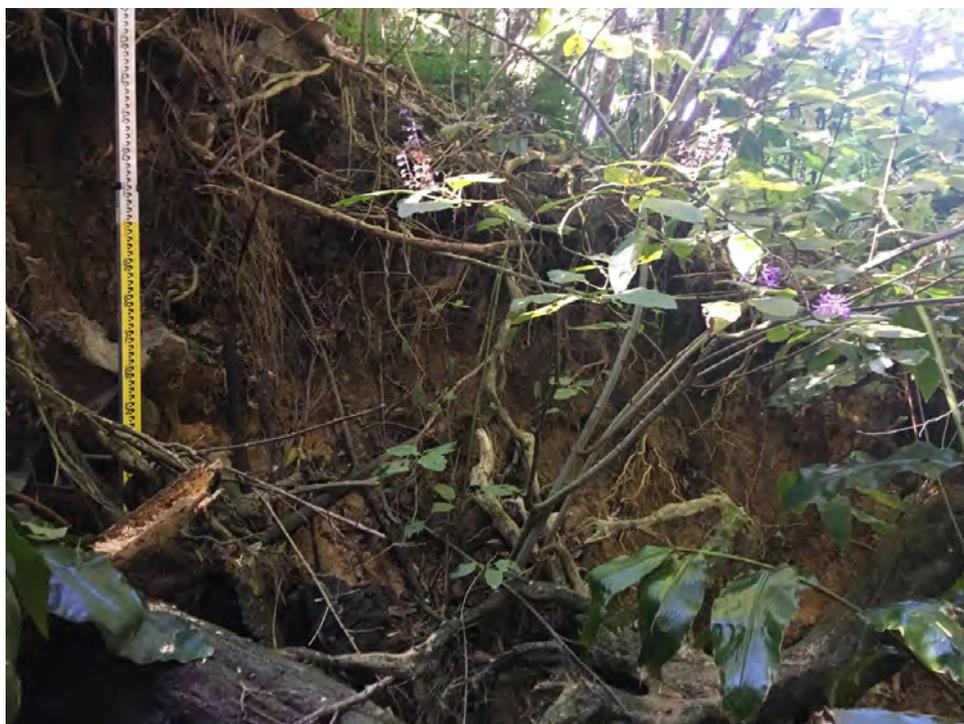
Figure 32. The erosion hotspot at KOH_TRIB7a_1 is associated with the stormwater outlet (Asset ID: 2000130324) shown on the top left-hand corner of the image.

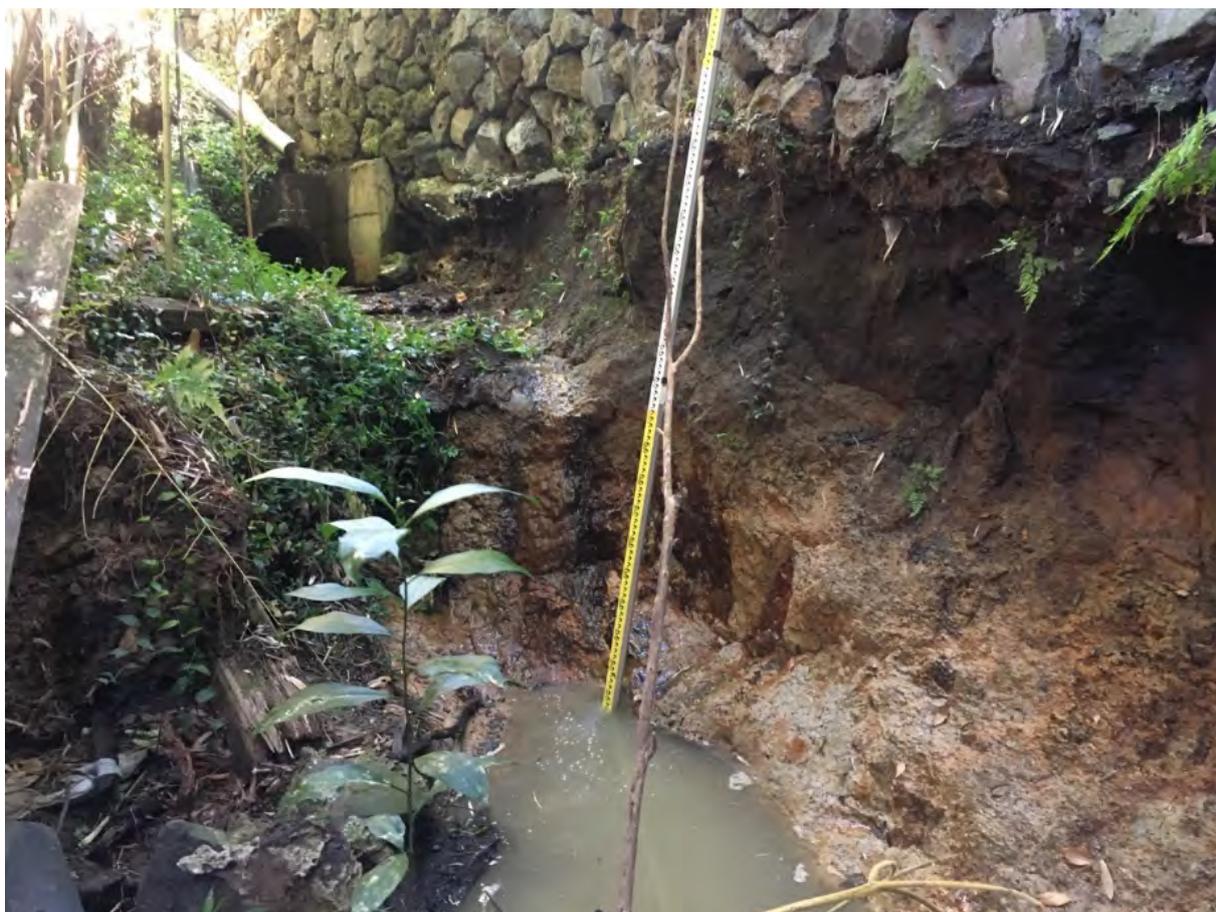
Figure 33: Erosion associated with under the retaining wall at 27 Geraldine Place along KOH_TRIB3a_5.

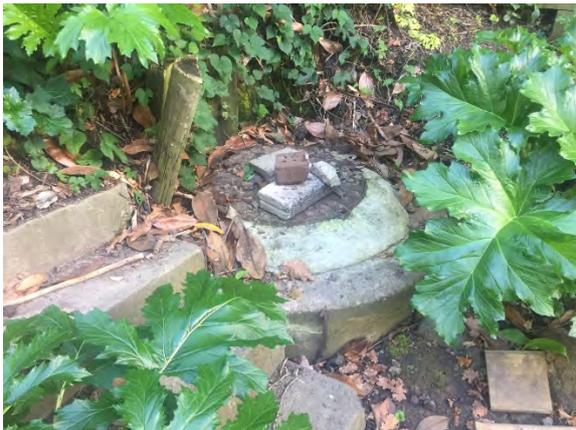
A possible stormwater manhole in the backyard of 4/36 Dingle Road (close to DIN_TRIB2_1) was reported to be popping open and causing local flooding in the back yard in rainfall events (Not in GIS).

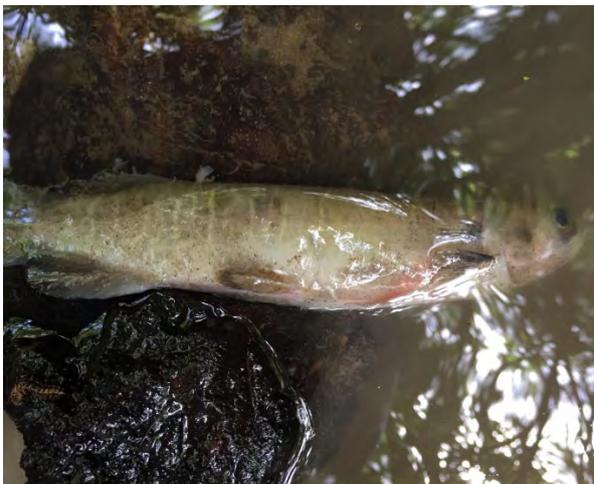
An upstream pool was discharging from 15 Fern Glen Road South into a road catchpit. In the Dingle Dell Reserve, approximately 300m downstream, two dead banded kokopu were found, potentially a result of the chlorine discharge (DIN_MAIN_3).

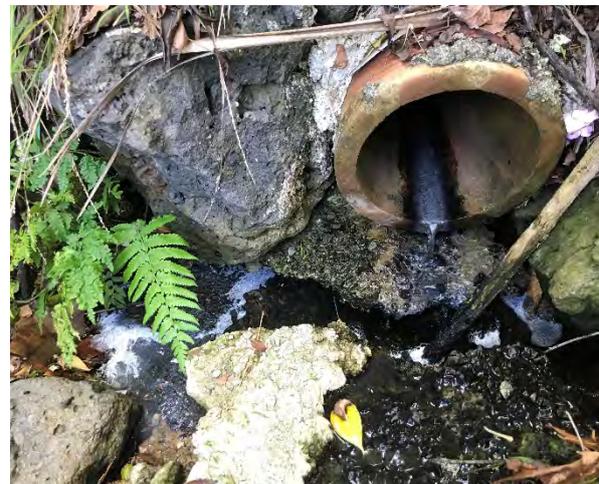
A white discharge was spotted coming out of an outlet (2000077826) into Mission Bay Stream (MIS_MAIN_1). At the property next door, a person was washing paint brushes into the stormwater drain and this is the likely source of the white milky discharge.

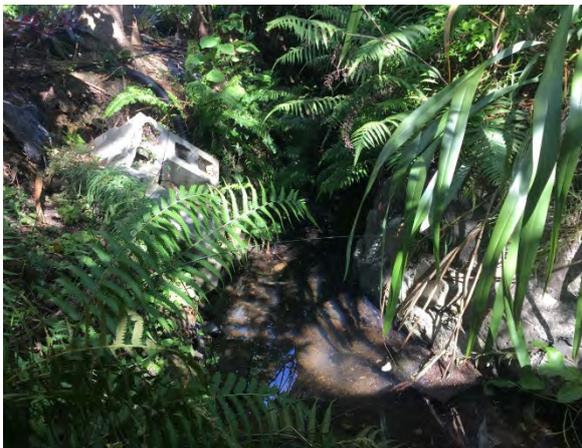
Mission Bay Stream EBG03 (MIS_TRIB4_1)
Reach on private land in variable condition with areas of bank erosion and other areas with good instream habitat.

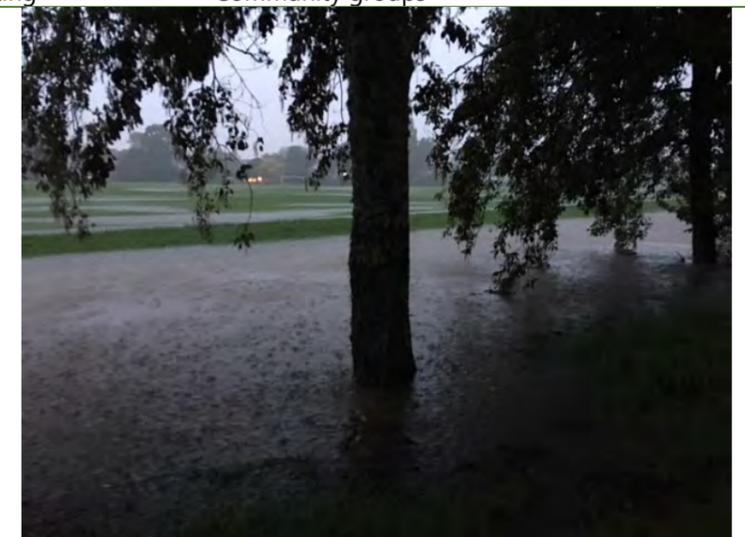
Flooding of field during heavy rainfall event in July 2018, from the TLB. Sent in by residents at 89 Esperance Road.

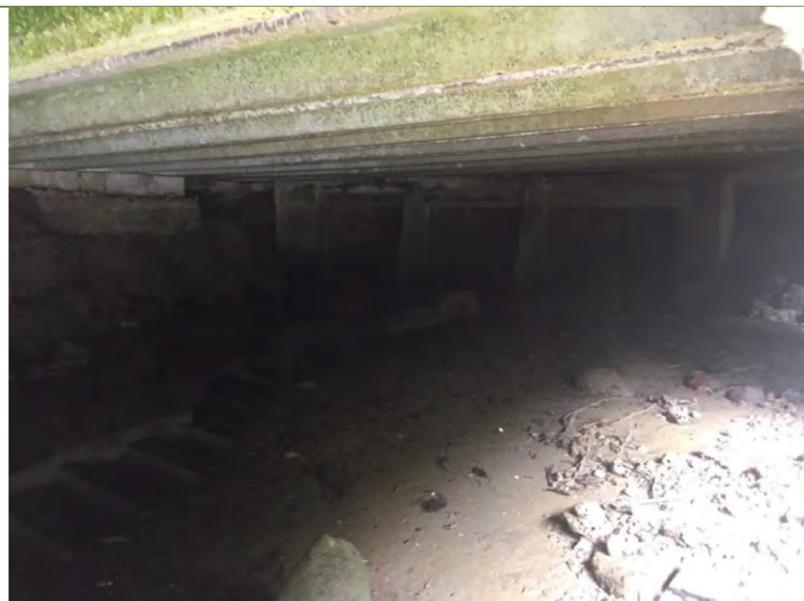
The 3 culverts (2000048193, 2000359099 and 2000671763) set back beneath parking garage.

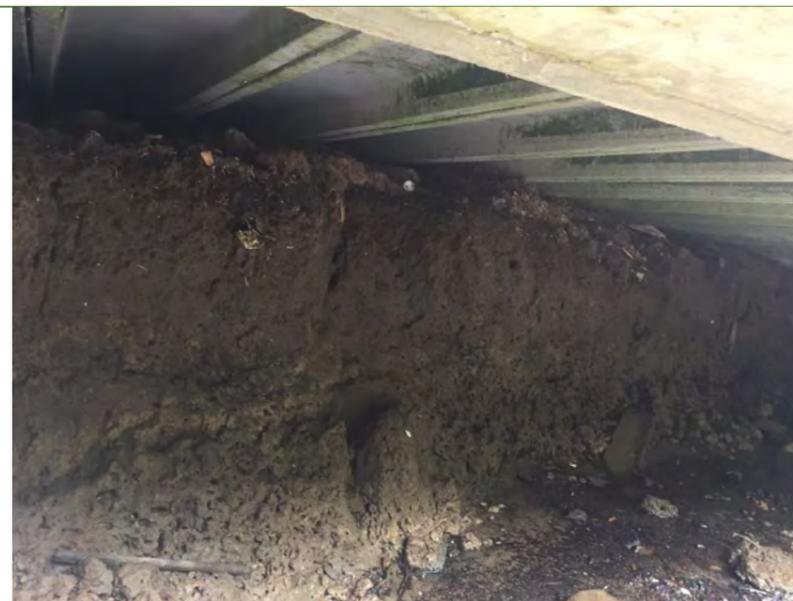
Undermining occurring the wall under the parking garage structure at 29 Tamaki Drive.

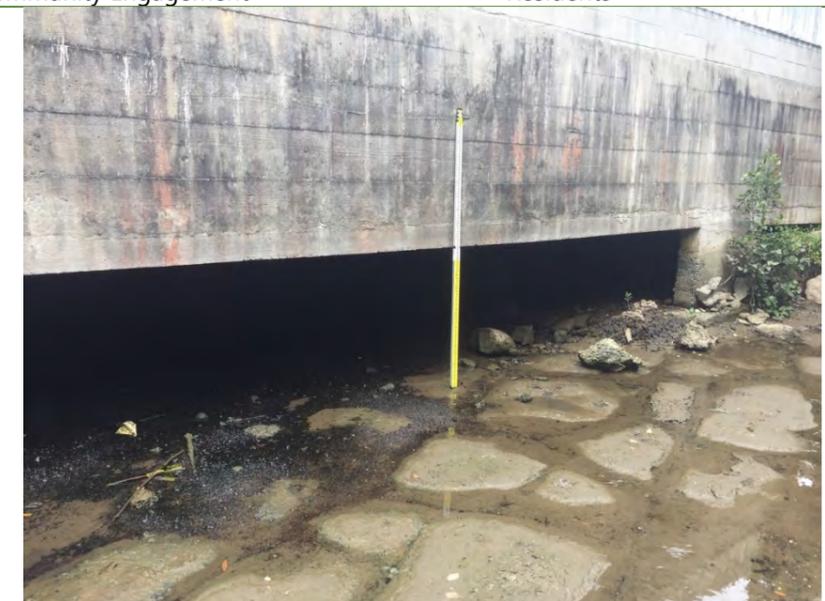
The main column supporting the parking garage was identified to have a large crack which may be compromising its structural integrity.

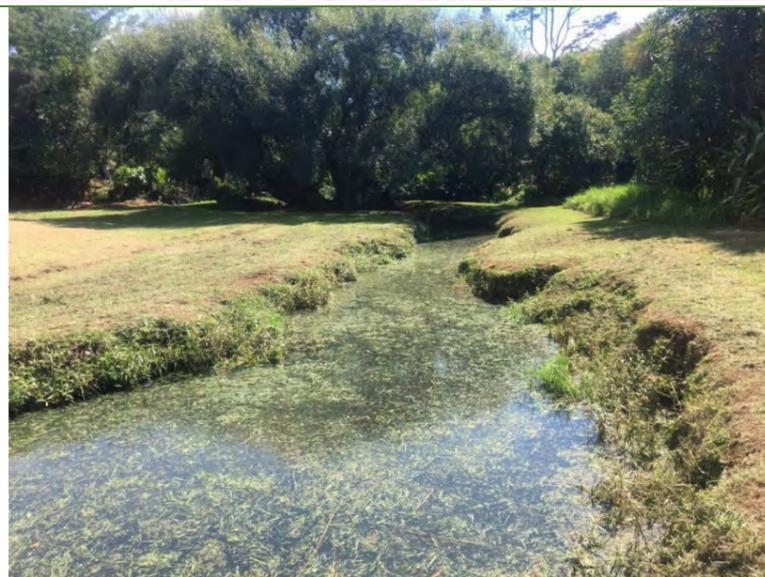
Open channel with dominated by lawn grasses providing limited filtering ability and no riparian shading (Trib ID: GLE_MAIN_3).

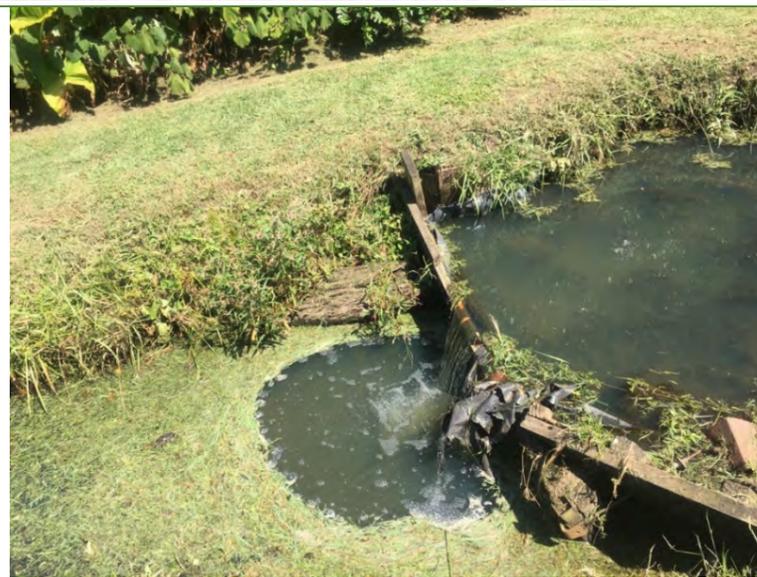
Multiple ad-hoc weirs and dams structures used to create ponding sections of stream.

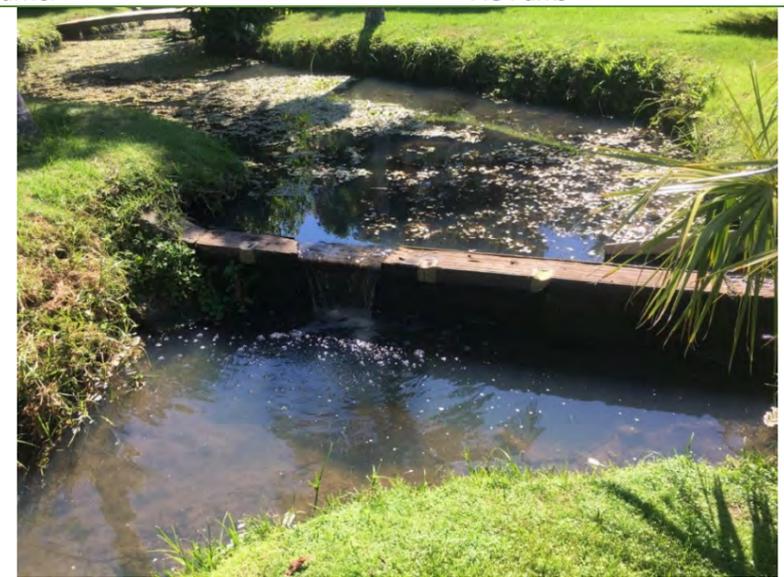
Weirs are complete fish passage barriers (GLE_MAIN_4).

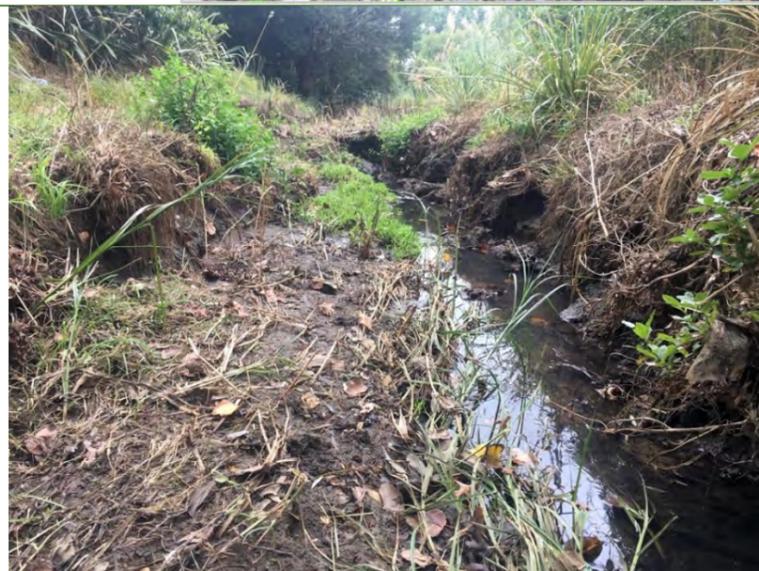
Mass wasting and slumping in the channel (Tributary ID: KOH_MAIN_10). Floodplain could be enhanced for inanga spawning habitat.

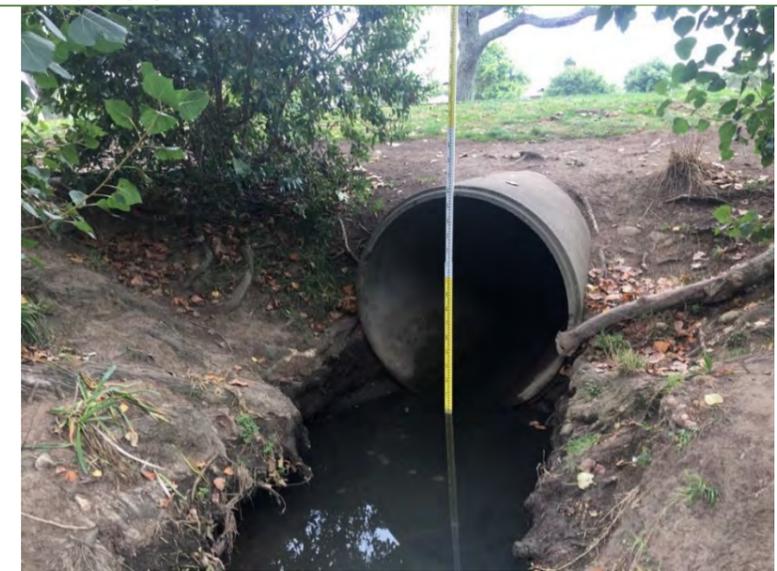
Asset ID 2000229311 with an unconstrained drop height of 1.6m close to the walking path.
