Eastern Bays and Glendowie Watercourse Assessment Report

Morphum Environmental Ltd, April 2020

Watercourse Assessment Report

Auckland Council
Healthy Waters Department
Watercourse Assessment Report

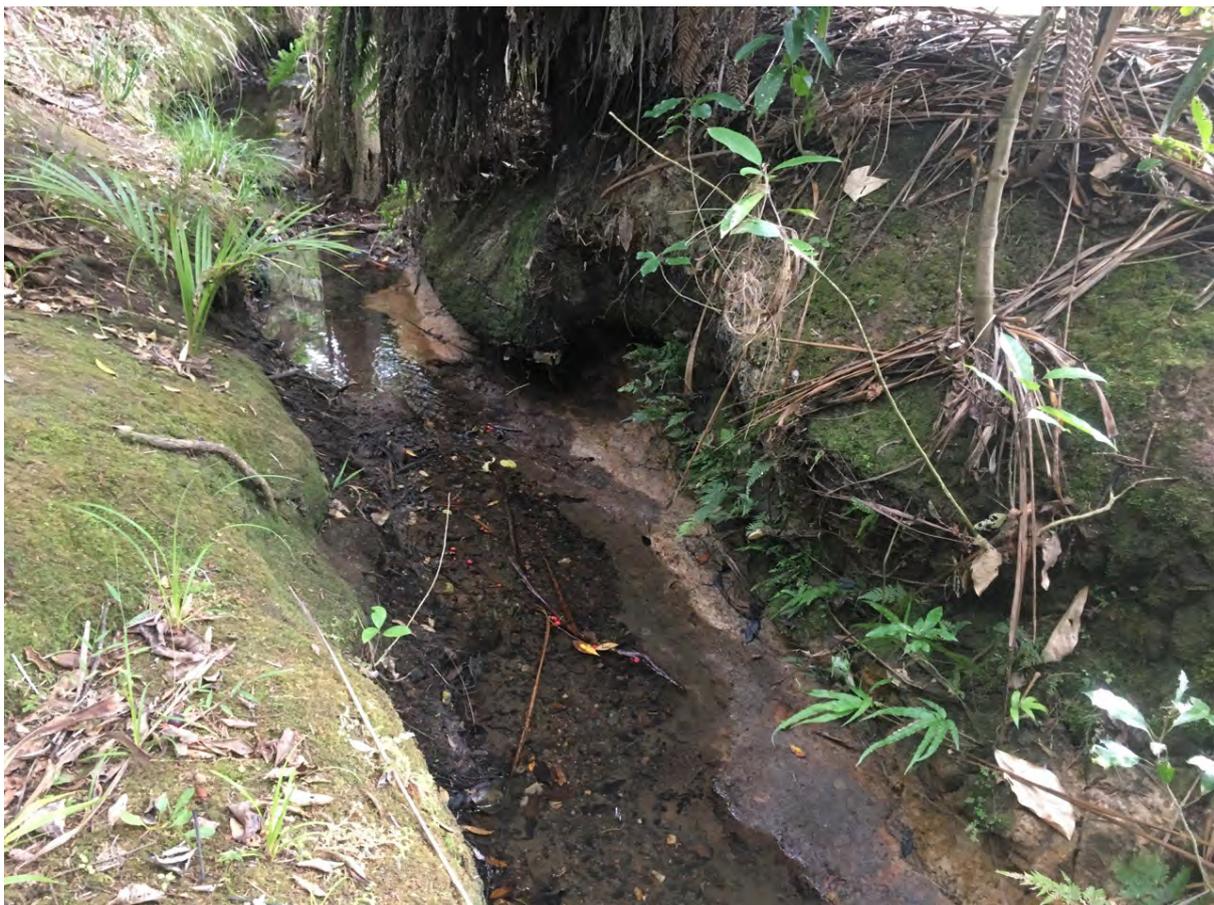
Figure 15: Reach in Dingle Dell Reserve with gravel beds potentially suitable for fish spawning (DIN_MAIN_3).

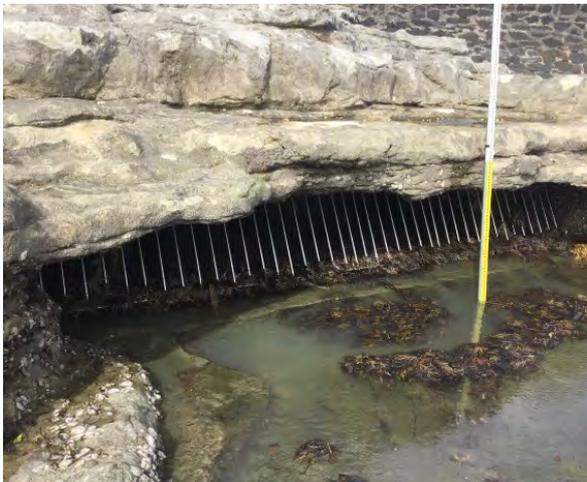
Auckland Council owned St Heliers coastal outlet with grill to trap debris is a partial barrier to swimmers and is likely to be temporal due to tides.

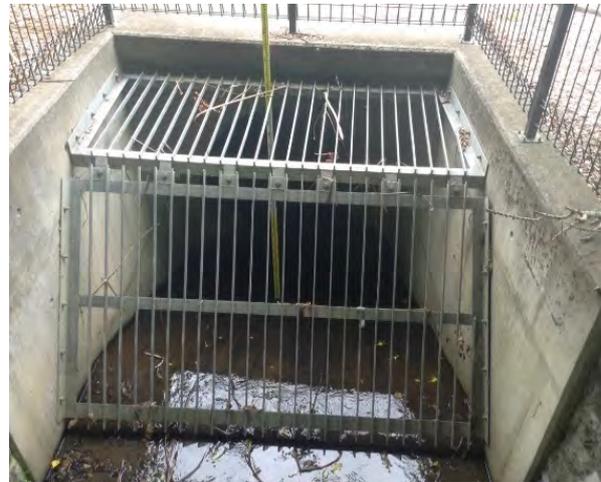
3. 7a Atkin Ave (2000082507, 2000258552) stormwater pipe dry at low tide and is affecting 1.28km of upstream habitat.
4. A culvert at the bottom of Dingle Dell reserve (2000919661) has a steep slope and a drop of 1m preventing swimmers but not climbers to access the 1.63km of habitat upstream.

Auckland Council owned inlet in Dingle Dell reserve (DIN_MAIN_2, 2000919661). A steep concrete ramp into the inlet was causing a barrier to swimmers.

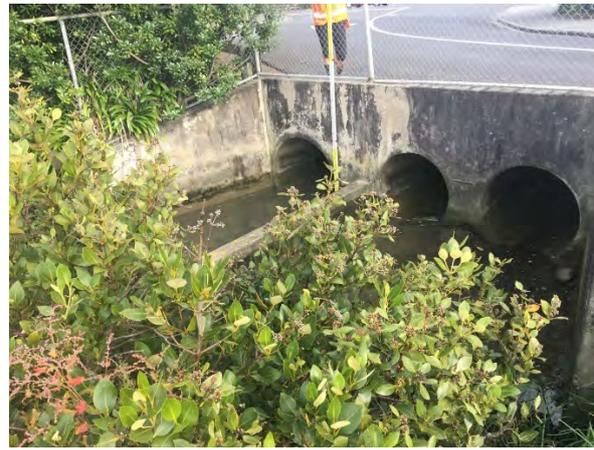
1. The Auckland Council owned coastal triple culvert on Glendowie Stream (GEE_MAIN_1, 2000621796, 2000816917 2000674479) which had a 0.04m drop from the apron to the coastal marine area/stream bed was affecting 550m of upstream habitat. This asset was assessed at low tide, so it is possible that it may be a temporary barrier that is tidally dependent (Figure 17).
2. An Auckland Council owned coastal outlet (2000473115) which discharges into the Glendowie Stream Mouth and coastal marine area has a 1m drop height across reno mattress into the channel bed. There is approximately 471m of open watercourse available upstream of this barrier however fish would have to swim up 118m of stormwater network (Figure 17).
3. A series of weirs present in Glendowie Stream (Tributary Code: GLE_MAIN_3) are causing complete barriers to a potential 760m of upstream habitat.

The Auckland Council owned coastal triple culvert on Glendowie Stream (GEE_MAIN_1, 2000621796, 2000816917 2000674479) which had a 0.04m drop from the apron to the channel bed.

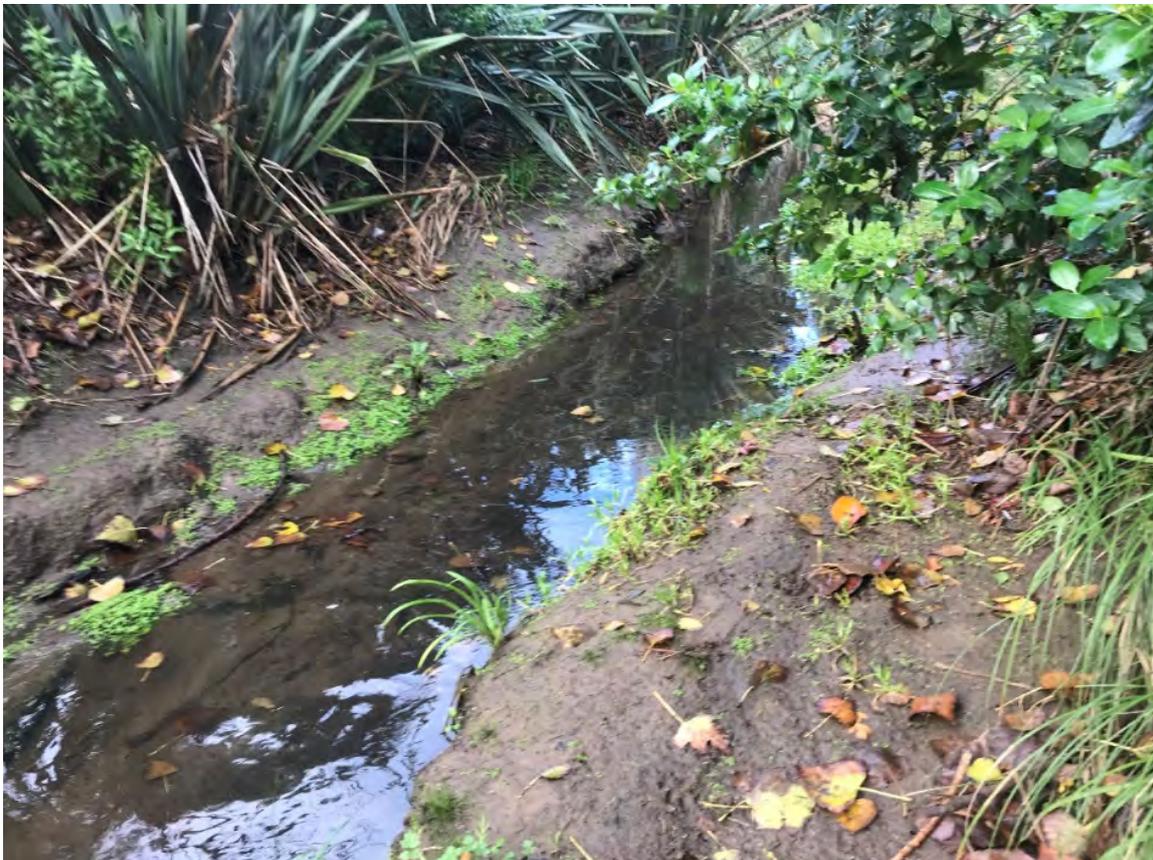
A reach (KOH_MAIN_11) in Madill's Farm Recreational Reserve has the potential to be suitable for inanga spawning if planted with suitable vegetation e.g. sedges (*Juncus* sp.) and oioi/jointed wire rush (*Apodasmia similis*) (see EO6). This area was identified as potential inanga spawning habitat due to wide low gradient floodplains with grass and flattened sedges that appear to be periodically inundated by tides (Figure 21).

Figure 21: Potential inanga spawning habitat with floodplain both banks that is periodically inundated by tides (KOH_MAIN_11).

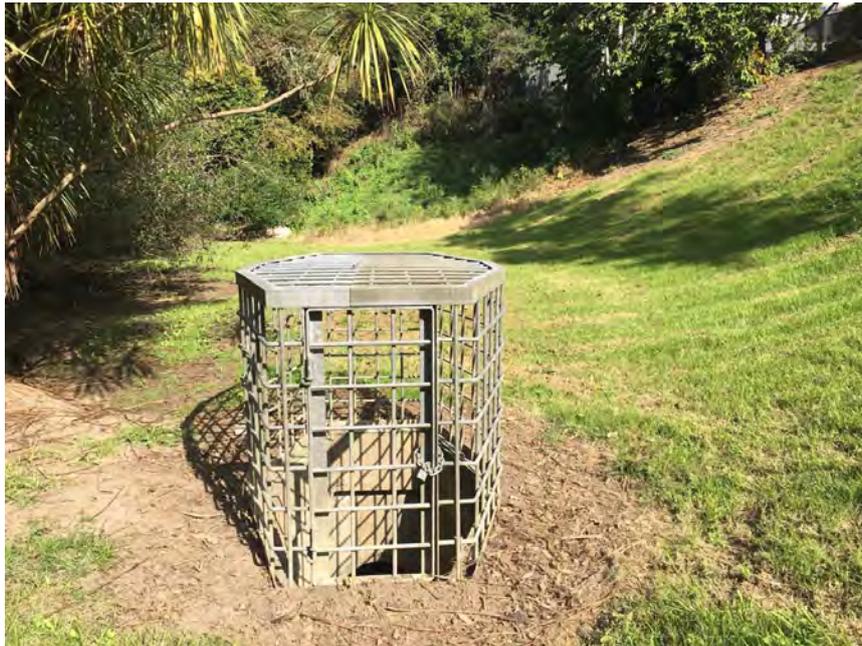
Figure 23: Dry Detention Pond located near (Tributary ID: KOH_TRIB6_1) constructed for stormwater management. The Council stormwater asset is located adjacent to private residential properties.

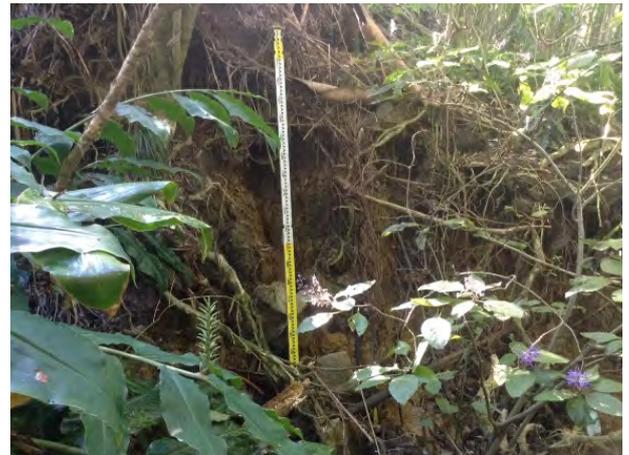
7. Severe erosion was occurring beneath the outlet point of the pipe at 92 Allum Street (2000565387) causing the dissipation structure to fall away. The structure had a greater than 1.5m drop. It was noted that although this asset might require replacement, it is not close to any structures nor is it posing any public risk.

The dissipation structure for the outlet at 92 Allum street (2000565387) has completely fallen away due to erosion.

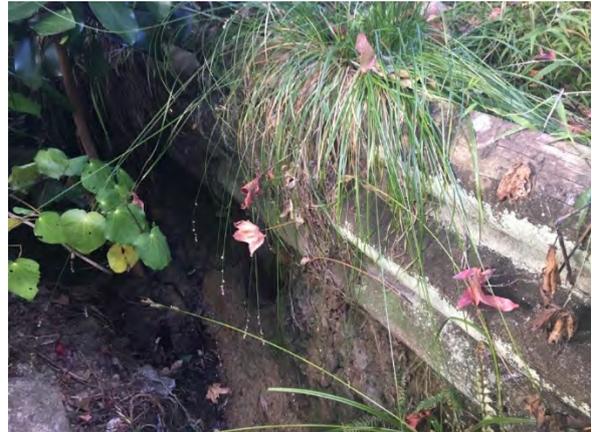
Bank lining at 18a Godden Crescent on private property (MIS_TRIB5a_1) (UNK_009).

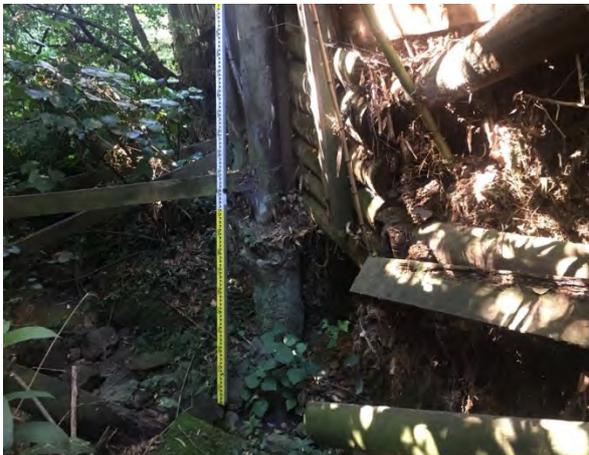
Bank lining undercut at 2/21 Geraldine Place (KOH_TRIB3a_5) (UNK_038).

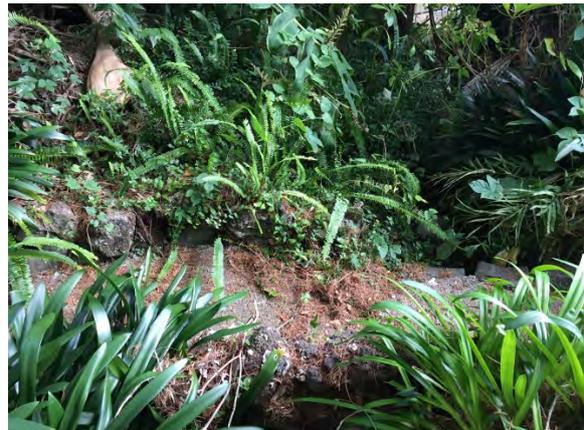
One miscellaneous point pose a potential risk for the flooding of habitable floors. A pedestrian bridge that crosses a tributary of Dingle Dell Stream, at the driveway of 35 Fern Glen Road had been completely blocked by debris and has the potential to flood habitable floors on 35 Fern Glen Road (DIN_TRIB4a_4) (Figure 34).

A pedestrian bridge that crosses a tributary of Dingle Dell Stream, at the driveway of 35 Fern Glen Road had been completely blocked by debris and has the potential to flood habitable floors on 35 Fern Glen Road (DIN_TRIB4a_4).

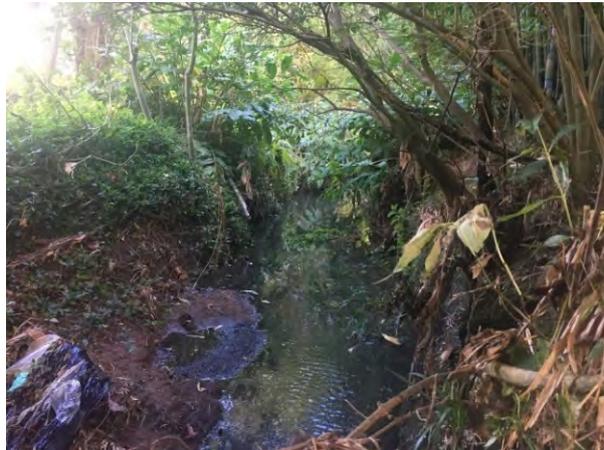
Glendowie Stream EBG02 (GLE_TRIB4_4)
Representative of residential reaches where weed infestations are common.

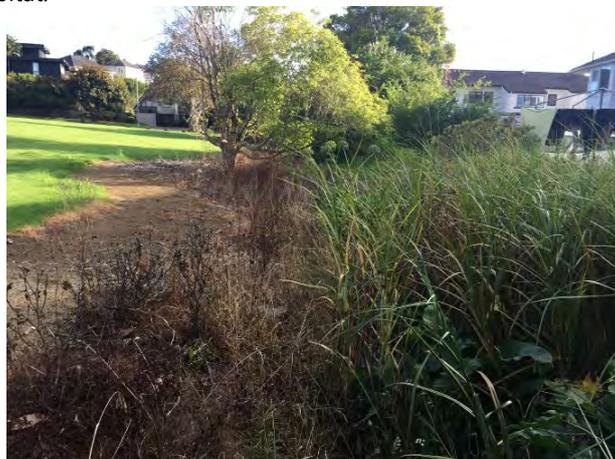
The Mission Bay Stream SEV site is representative of a public access stream with poor longitudinal extent of riparian cover and small to no banks. The SEV score of 0.370 indicates poor ecological condition as a result of very poor biodiversity and very poor habitat provision.

Mission Bay Stream EBG05 (MIS_MAIN_1)
Representative of streams with poor riparian vegetation and shallow banks.

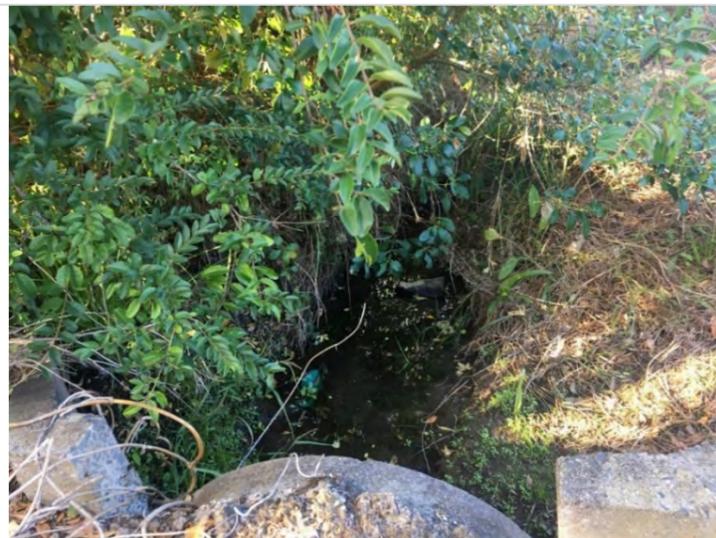
Outlet at the top of stream (SAP ID: 2000077826, 2000077826) showing low banks and poor vegetation.

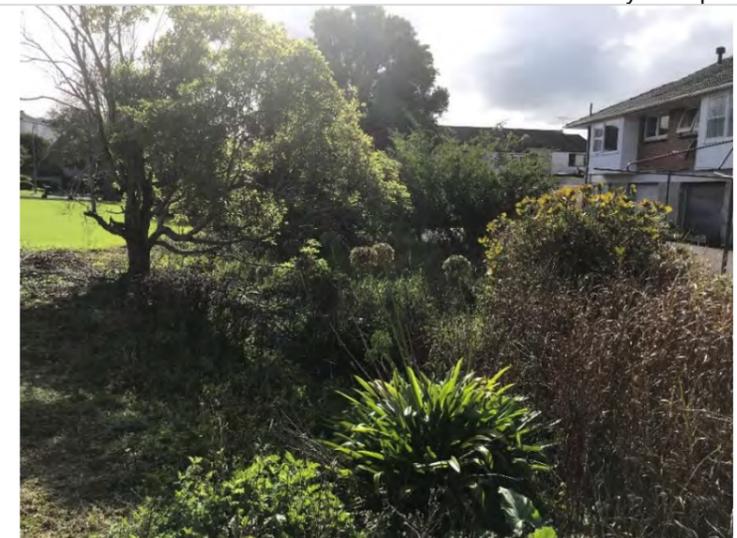
Narrow riparian longitudinal extent at MIS_MAIN_1.

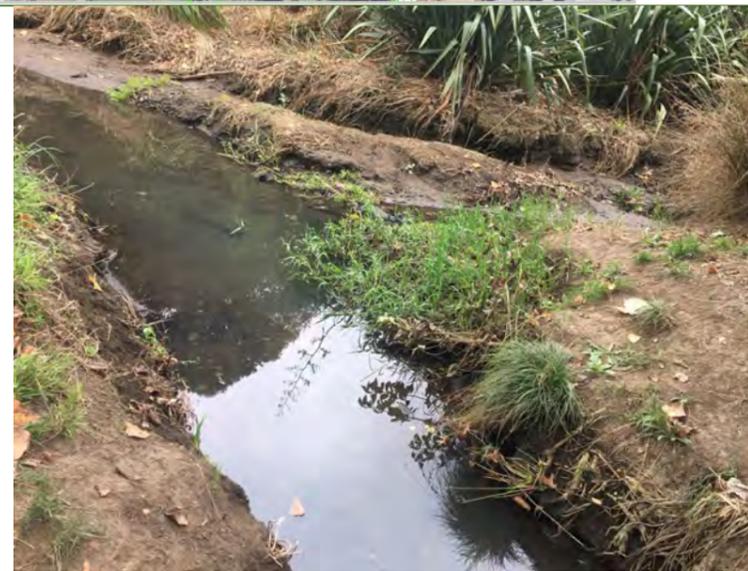
Erosion where the flows from the outlet (asset ID: 2000229311) hit the adjacent bank.
